155-mm Howitzer Malfunction Investigation: A Laboratory Study of the Igniter Train Operation

ARL-TR-2106

November 1999

Army Research Laboratory

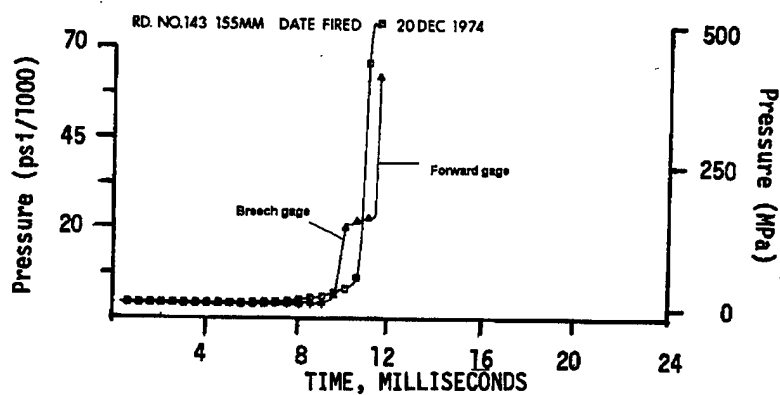
- Round 142: Hangfire, 10 s (minimum, not measured); muzzle velocity, 857 m/s (2,812 ft/s) and 61 m/s (200 ft/s) higher than a normal cold round; mean chamber pressure, 379 MPa (55,000 psi) and ~ 110 MPa (16,000 psi) higher than a normal cold round.
- Round 143: Hangfire, 5.8 s (measured); erratic pressure vs. time trace with a chamber pressure in excess of 793 MPa (115,000 psi) causing a breechblow and extensive damage to the XM199E5 cannon tube. The pressure vs. time history for this round is shown in Figure 2.

Figure 2. Pressure-Time Trace of Breechblow Round Fired at APG With XM203E1 Charge Conditioned to -54° C in XM198 Howitzer.

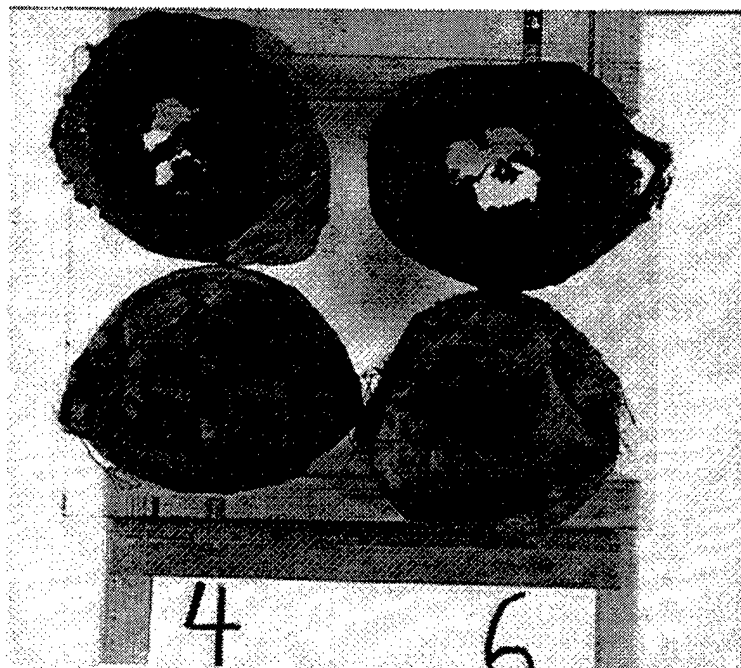
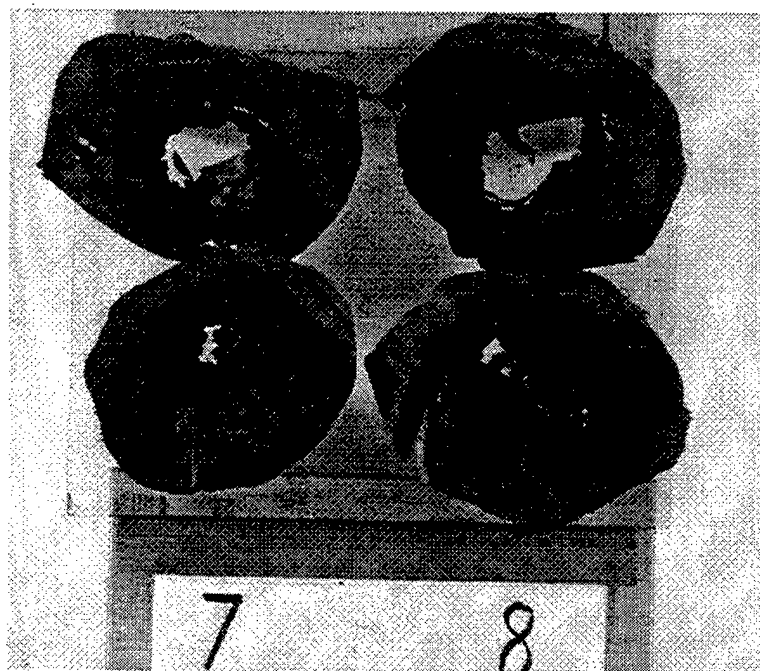
3.1.4 Run 6. Runs 4 (-54°C) and 6 ($+12^{\circ}\text{C}$) post-firing photos are shown in Figure 7(a). It is seen that there are no significant differences between the low-temperature and ambient firings. Results in Table 1 indicate that the time to peak pressure is slightly longer for the cold runs (54 ms) than for the ambient runs (35 ms). However, no events with delays in the range of seconds were observed. Pressure-time traces are shown in Figures 8 (Gauge 1) and 9 (Gauge 3).

3.1.6 Run 8. Results were very similar to that of Run 5, which used the 203 material at -54°C . The post-firing photo of base pad and propellant bag of Runs 7 and 8 are shown in Figure 7(b).

Figure 7. Post-Firing Photographs of Bass Pad (Top) and Propellant Bag (Bottom). 28 g (1 oz) of Black Powder Used in Base Pad; (a) 203, (b) 123.

Again, no significant difference is seen due to the conditioning temperature. Close observation of Figure 7 shows, however, that there are some differences in cloth penetration between the 123 (viscose-rayon impregnated resin) and the 203 (polyester-viscose rayon). The 123 cloth (Figure 7[b]) is more subject to ignition damage than the 203 cloth. In fact, no penetration of the propellant bag is observed in Figure 7(a), whereas there are several holes in the propellant bag in Figure 7(b). Apparently, this difference in cloth had no substantial effect on the operation of the black powder, but it did inhibit the damaging effect of primer black powder output on the propellant bag. Pressure-time traces are shown in Figures 13 (Gauge 1) and 14 (Gauge 3).

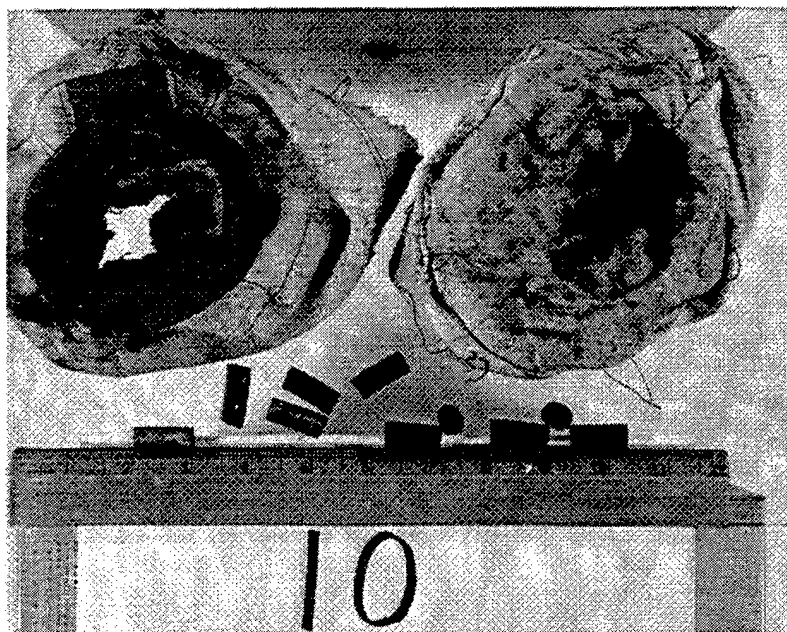
Figure 15. The 203 Base Pad (Left) and Propellant Bag (Right) for Run 10. Propellant Grains Placed in Base Pad. Some Graphite Coating Removed From the Grains by the M82 Output. No Evidence of Reaction.

grains, but there is no evidence of propellant reaction. It may also be noted that there was no penetration of the propellant bag.

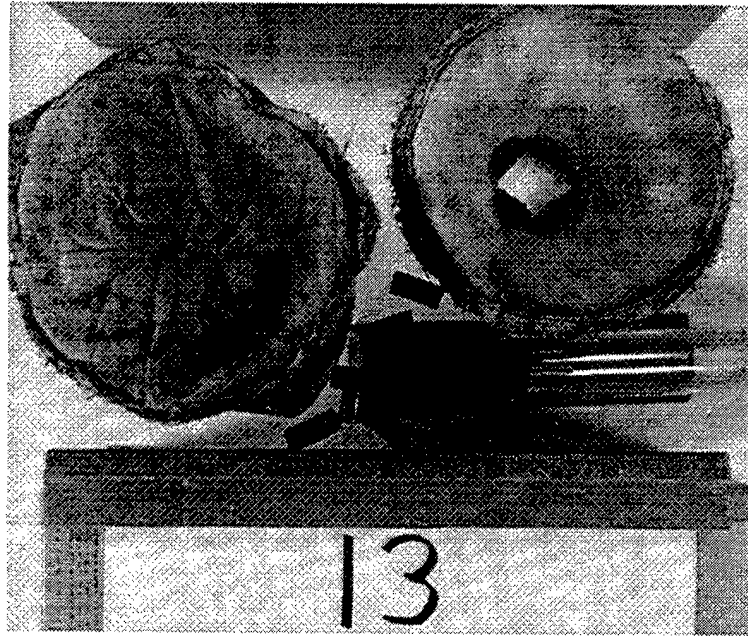
Figure 16. Post-Firing Photograph of Run 13: Propellant Bag (Left) and Flash Reducer (Right).

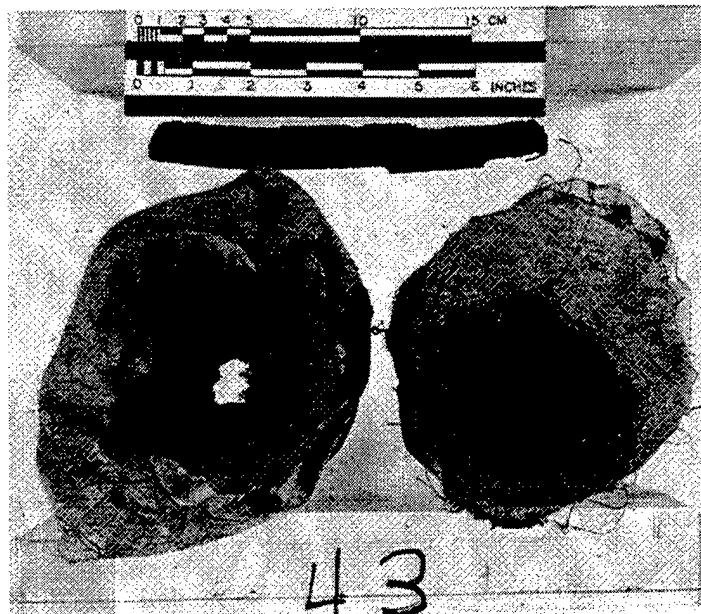
3.7.5 Run 43. For this run and Run 44, a flash reducer was put on the far end of the charge (in front of Gauge 3, Figure 3[a]). The reason for this was because the pressure pulse from the M82 was reflected at the far end of the charge against the Gauge 3 wall. This could raise the gas temperature considerably and enhance the possibilities of ignition of the snake. (Runs 15 and 26–29 were carried out in this manner). The flash reducer would deflect the pressure pulse and inhibit this mechanism. For this run only, the NC tube ignited. The snake cloth was charred, but the black powder did not ignite (Figure 27). This test also demonstrated that the NC tube could itself ignite but that it would not necessarily ignite the black powder. Thus, it is conceivable that the M82 would ignite the end of the NC tube and this, in turn, could ignite the propellant without igniting the black powder snake.

Figure 27. Post-Firing Photograph, Run 43. Base Pad (Left Empty), Snake (Top 0.05 kg [1.75 oz]). NC Tube Completely Burned Up. Snake Cloth Was Charred, but Black Powder Did Not Ignite.

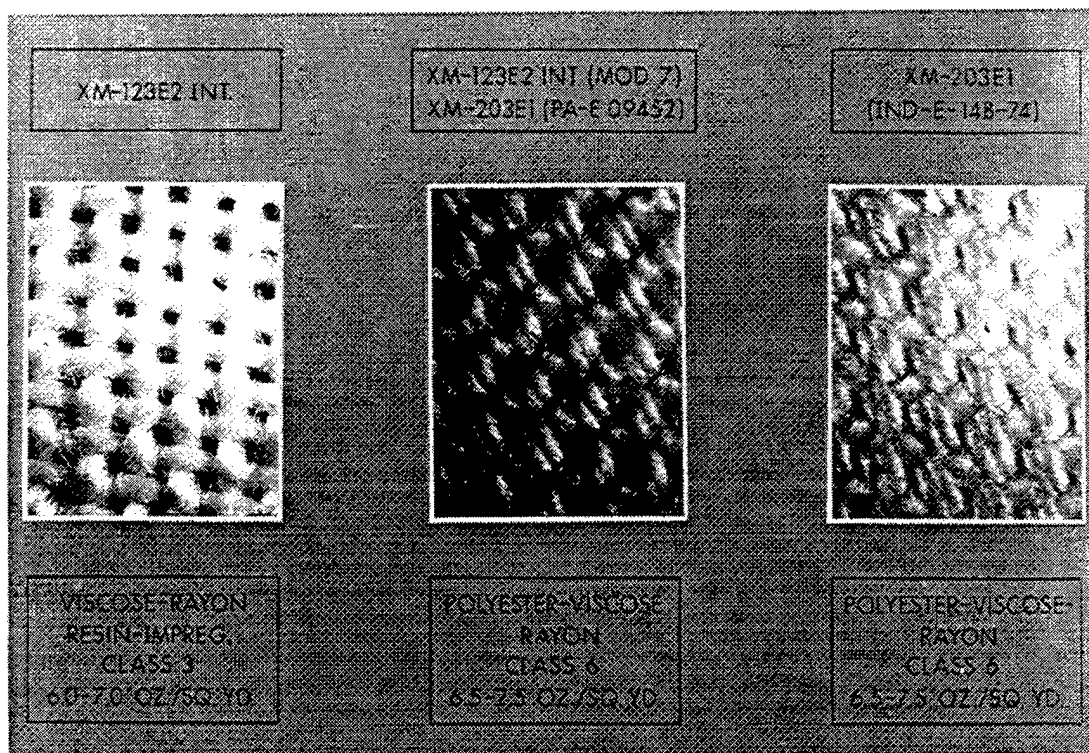
In referring to Figure 43, it can be seen that there is a substantial difference in cloth porosity between the cloth used in the 123 charge and the cloth used in the 203 charge. Only the inner base pad cloth is shown. Figure 7 shows the residue of the base pad (top) and propellant bag (bottom) after firing of an abbreviated charge, as in Figure 4. The base pad contained 28 g (1 oz) of black powder, there was no snake, and an inert central core tube was used.

Figure 43. Inner Lining of Base Pad Cloths Used in 123 Interim (Left) and 203 (Right). The XM123E2 Interim (Mod 7) Cloth Is Not Discussed in This Report.

It is seen that the penetration of and damage to the propellant bag is substantially greater for the 123 system than the 203 system. Apparently, the heavier cloth with a finer weave inhibits the transfer of energy into the propellant bed. The pressure-time curves of two different base pads (Figures 5 and 13) do not show any substantial difference, which indicates that the overall energy output is not altered and only the transfer of energy to the propellant is affected by the cloth.
